Application Advisory

Assemblies Affected:
 XTR39

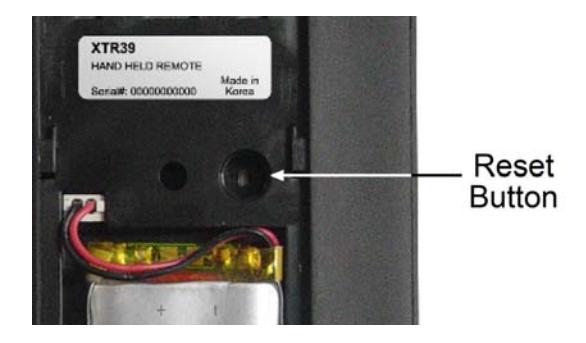
Symptom:
 Can't communicate, query, transfer firmware or project to XTR.

Cause:
 XTR may be locked

- 1) Open Universal Dragon
- 2) Click base unit>upgrade>XTR.
- 3) Select the latest firmware or highest revision firmware in the current firmware folder (Do not click open or start the transfer). Current firmware's can also be found on Xantech.com.
- Press the reset button under the battery cover. Reset is the larger round circle. Note: (If the unit passes the boot loader screen restart the process). Now click open to start the transfer process when or before the boot loader screen appears.
